# ROOF CONDITION ASSESSMENT REPORT

**SITE: 100 Lynn Williams Street, Toronto ON**

**DATE: May 30, 2025**

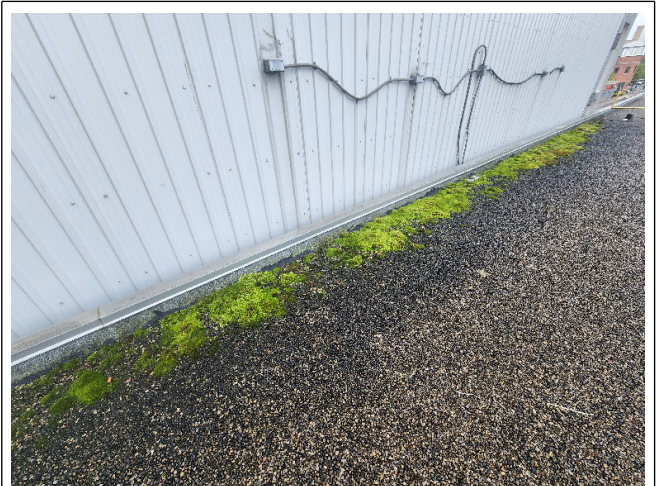
④ Description:  
An abundance of moss along the front of the building, indicating excess moisture sitting along the wall.

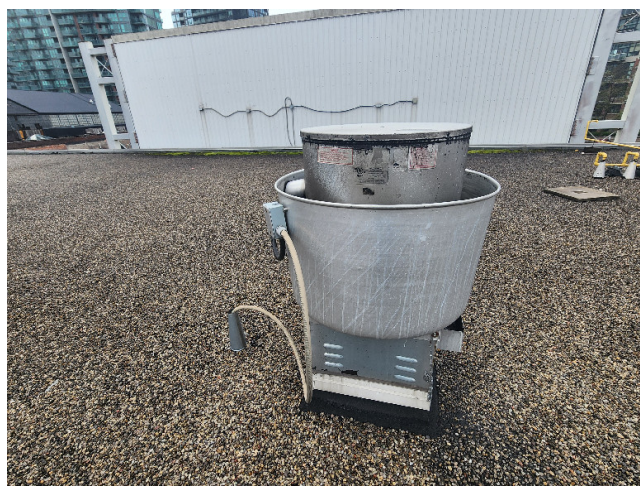
**5** Description:

Open roof cone needing to be sealed in order to keep it watertight.

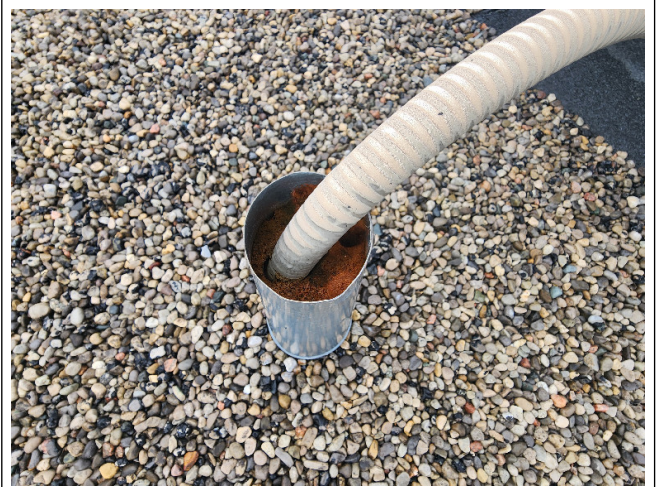
**6** Description:

A close-up of the open roof cone for the electrical conduit.

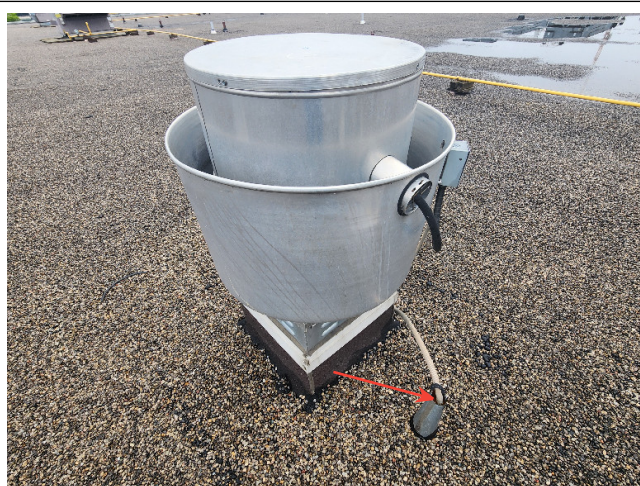
**7** Description:

Another open roof cone noted on this roof area.

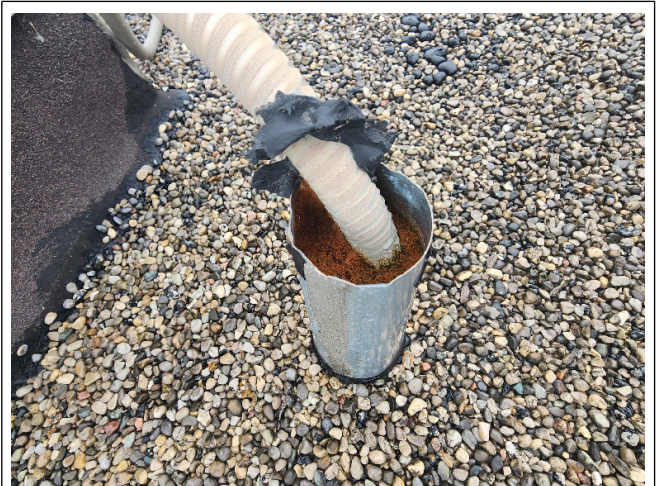
**8** Description:

A close-up of the open roof cone, showing the exposed sprayfoam insulation.

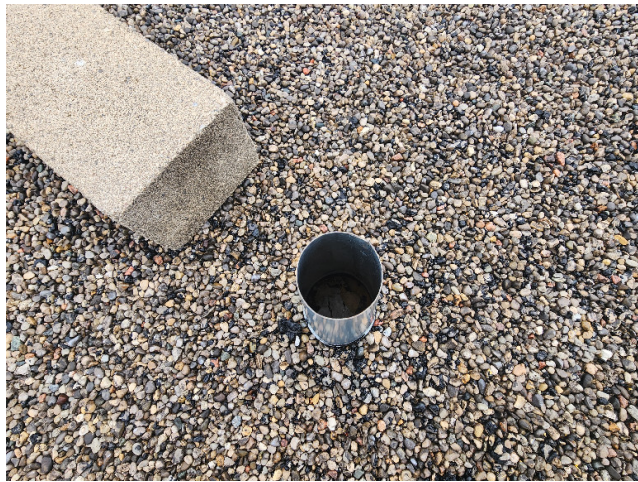
**9** Description:

Open roof cone will need to be covered to prevent water and debris to enter.

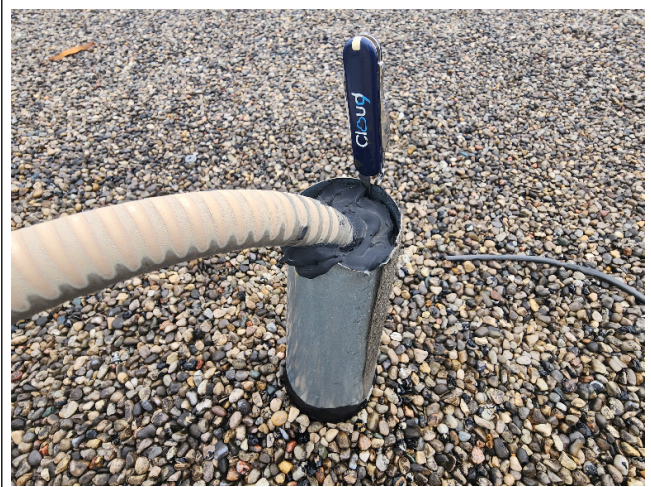
**10** Description:

Opening in the sealant of the cone.

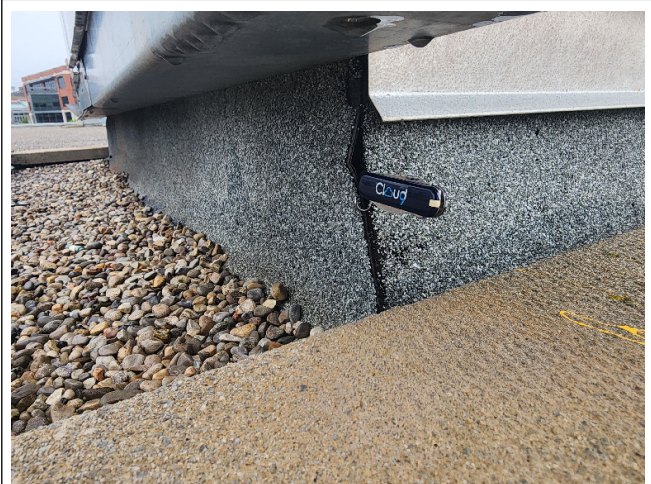
**12** Description:

Opening in the flashing under the HVAC unit allowing for moisture infiltration.

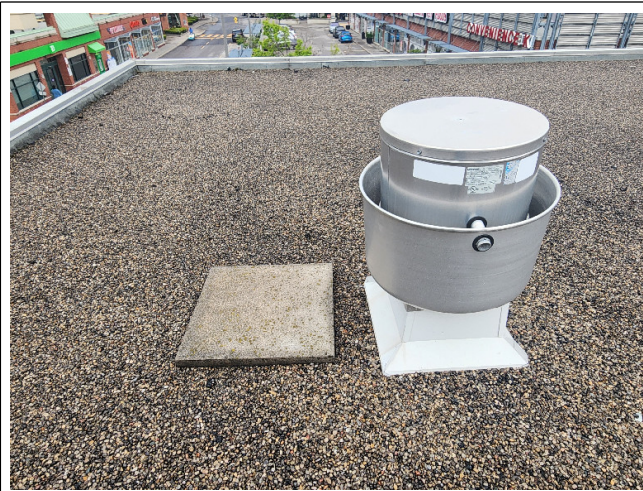
**13** Description:

Missing insulation under the concrete roof paver.

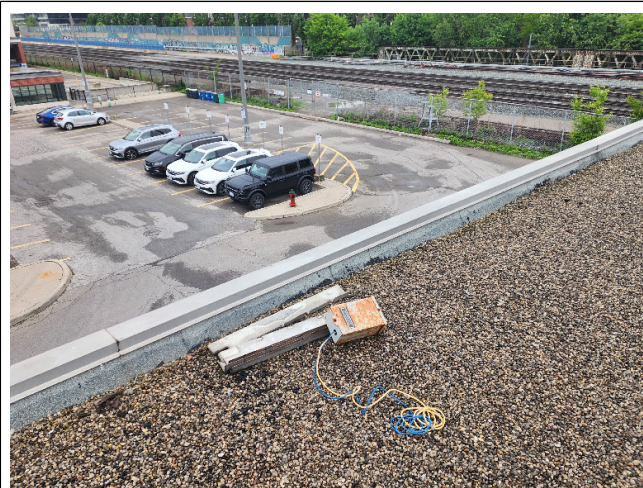
**15** Description:

Debris that should be removed from the roof before it blows over the parapet.

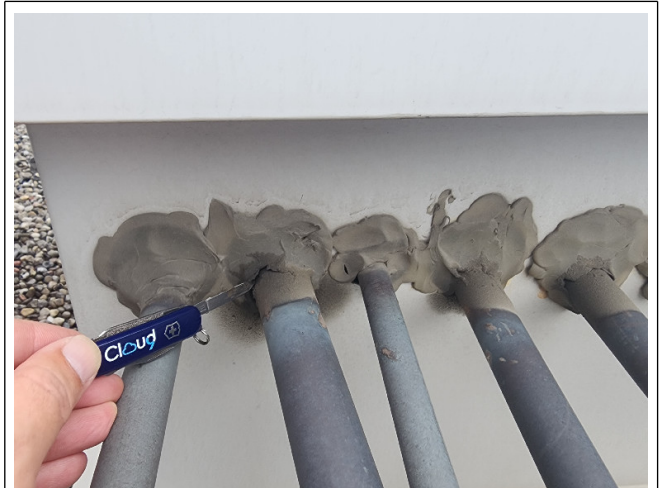
**16** Description:

Opening in the sealant on the dog house.

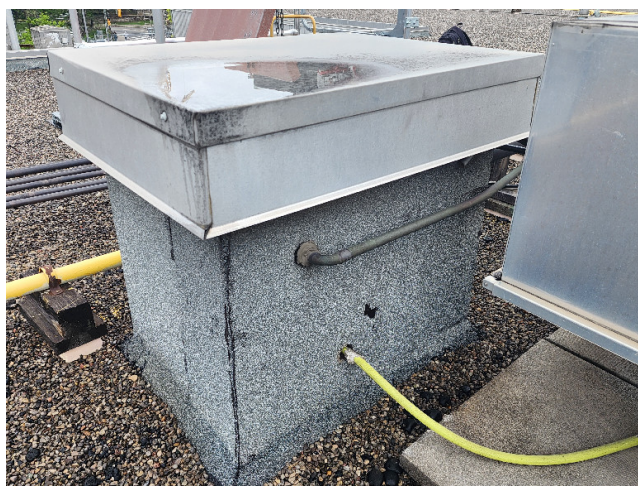
**17** Description:  
Opening on the doghouse.

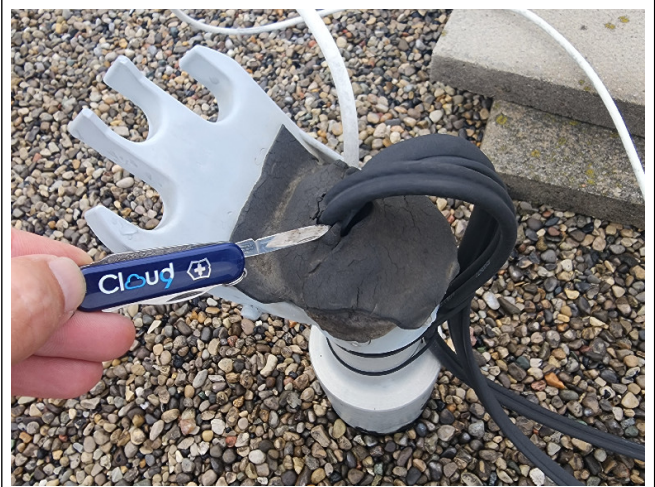
**18** Description:  
Open sealant at a roof cone.

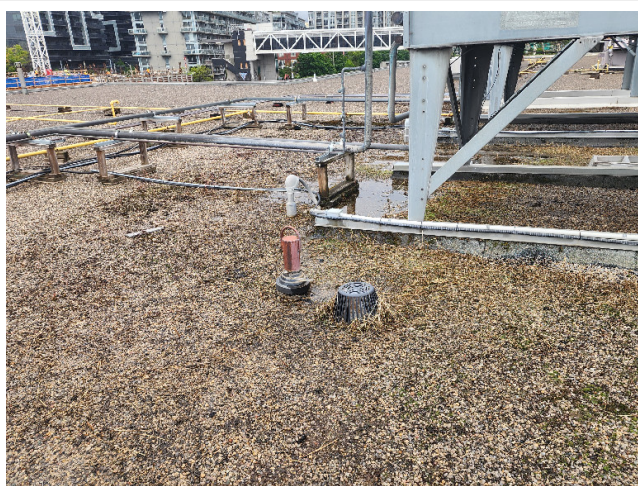
**19** Description:  
Overview of large amounts of organic debris around the roof drain.

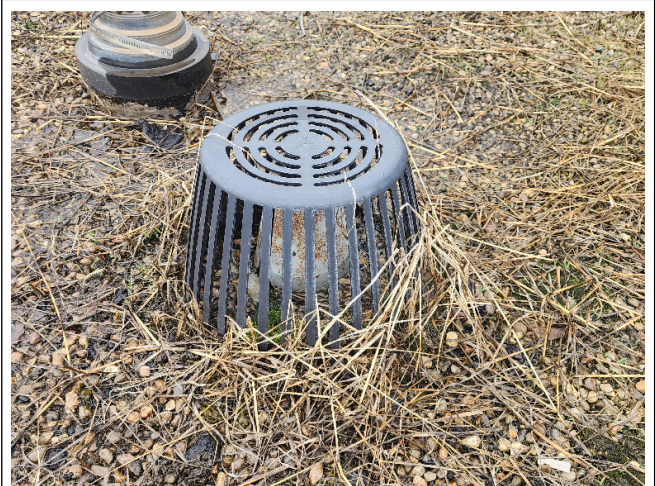
**20** Description:  
Organic debris built up around the roof drain not allowing for proper drainage.

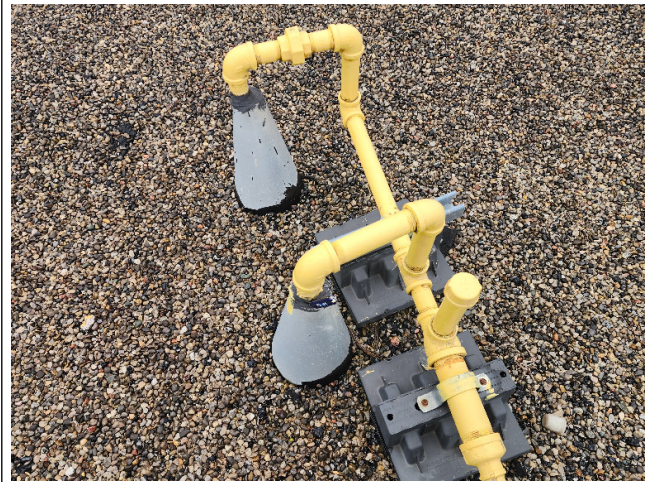
②2 Description:

Open sealant at the gas line penetration.

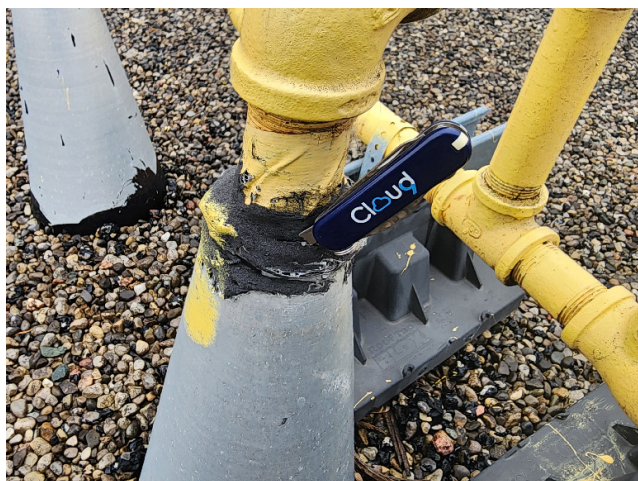
②3 Description:

A close-up of the open sealant.

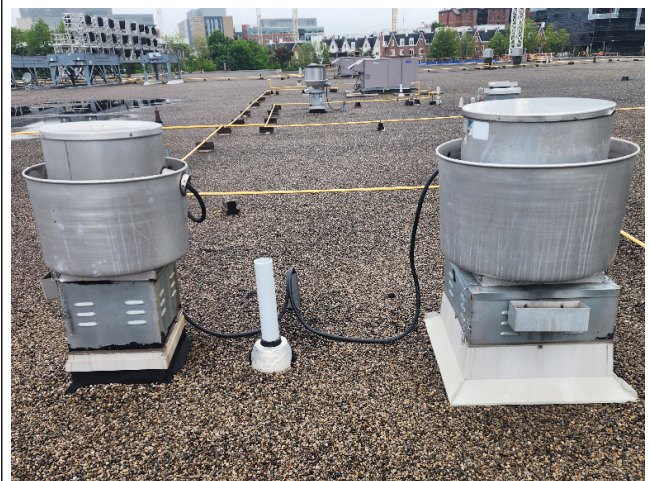
②4 Description:

Another open roof cone needing to be sealed.

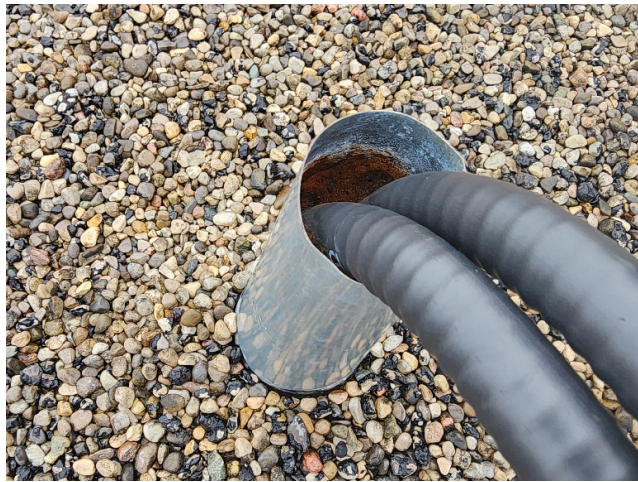
25 Description:

A close-up of the open cone.

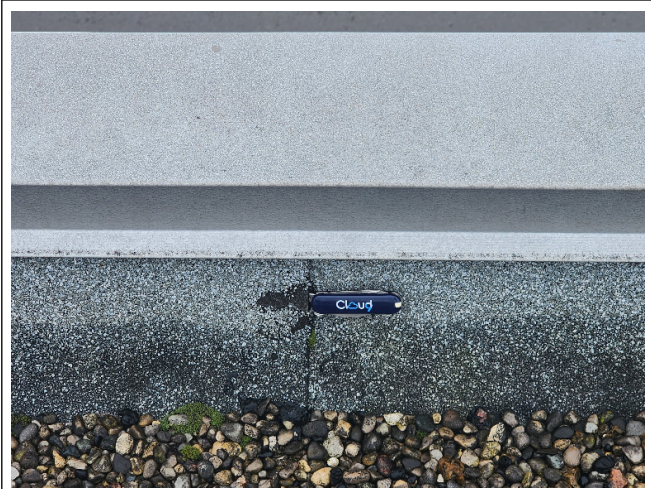
26 Description:

Open lap in the flashing membrane.
