**EBS Innovations Inc.**

**SITE: 100 Lynn Williams Street, Toronto ON**

**DATE: May 30, 2025**

## Condition Assessment

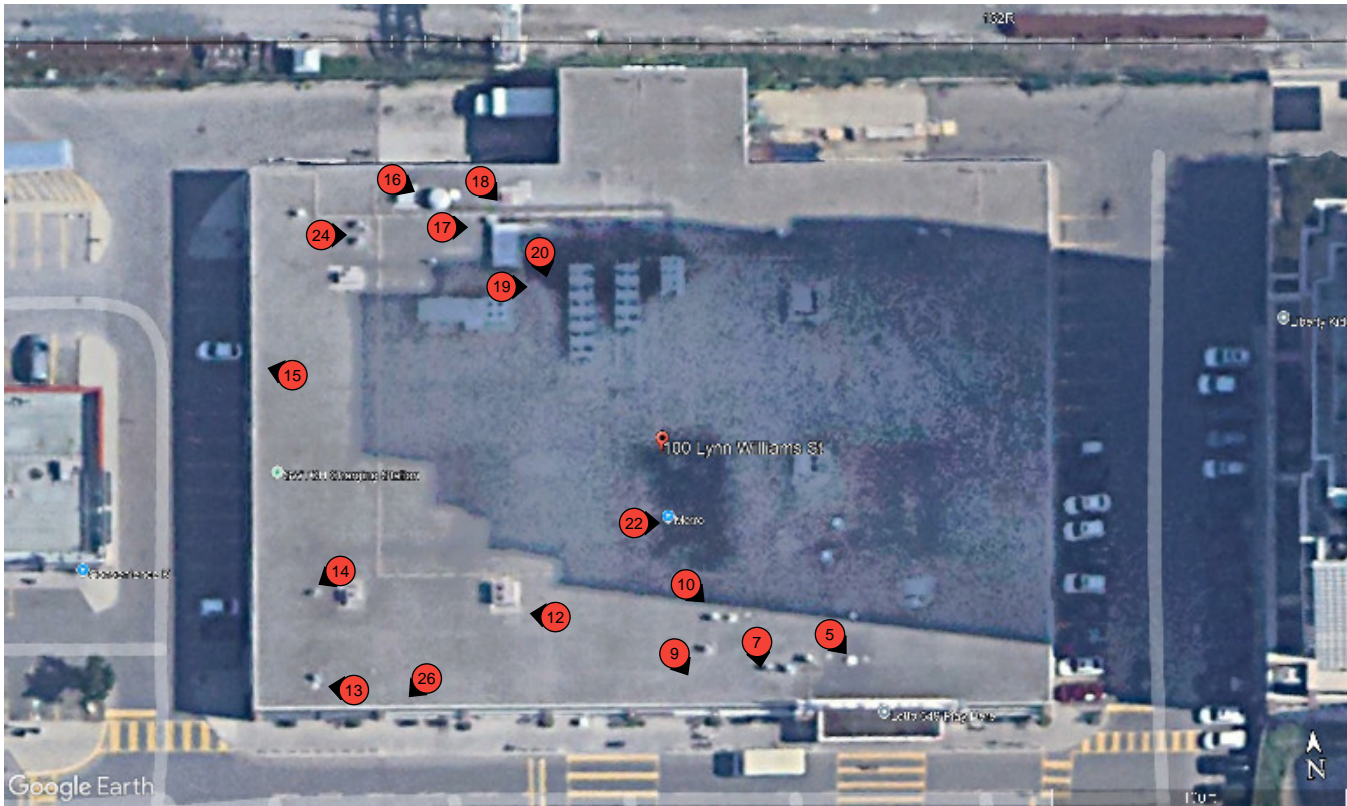
**ROOF PLAN:**

A roof plan was prepared showing all of the designated roof areas, rooftop equipment, roof penetrations, deficiencies, and other pertinent information.

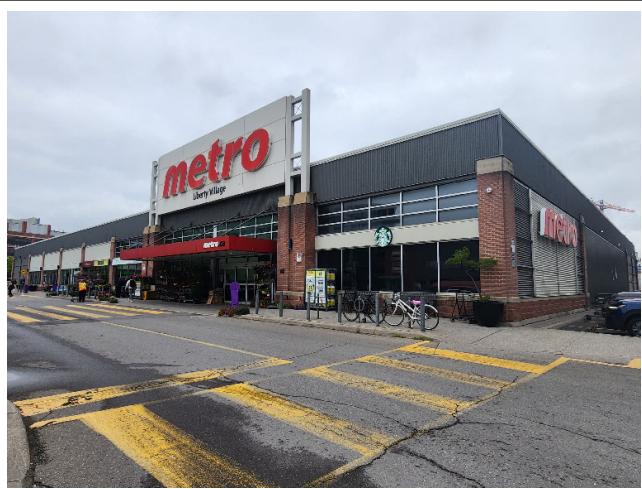
① Description:  
Building overview.

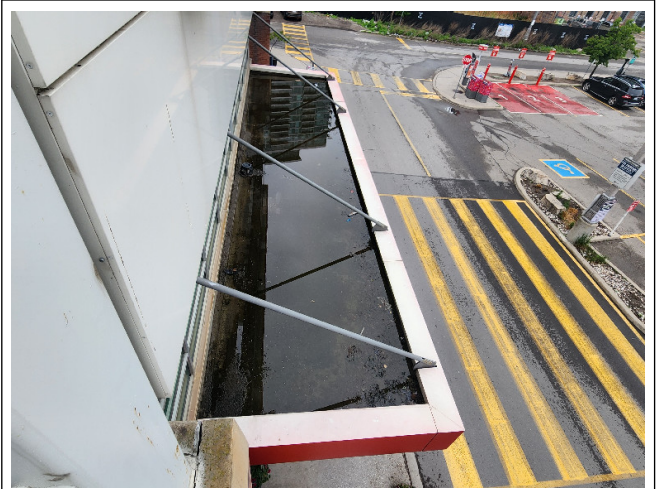
② Description:  
Overview of roof area 1.0.

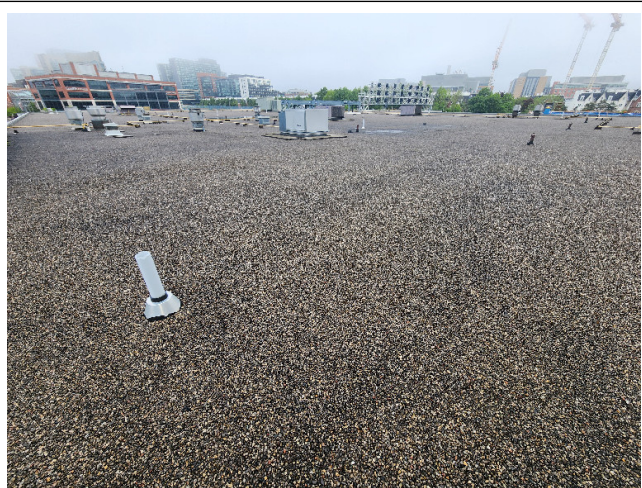
③ Description:  
Overview of roof area 2.0 (main roof level).

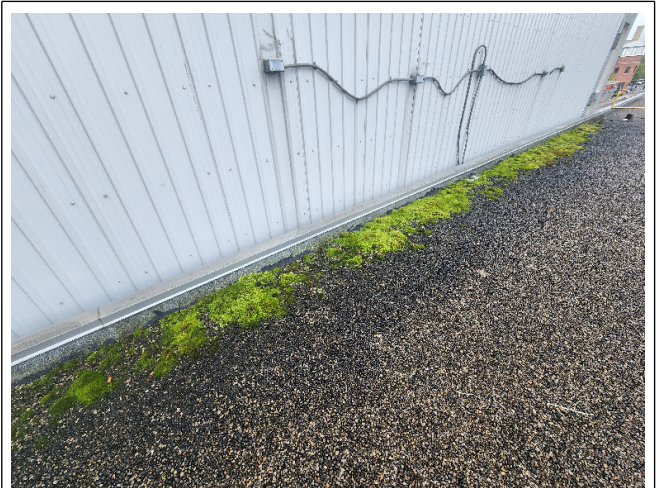
④ Description:  
An abundance of moss along the front of the building, indicating excess moisture sitting along the wall.

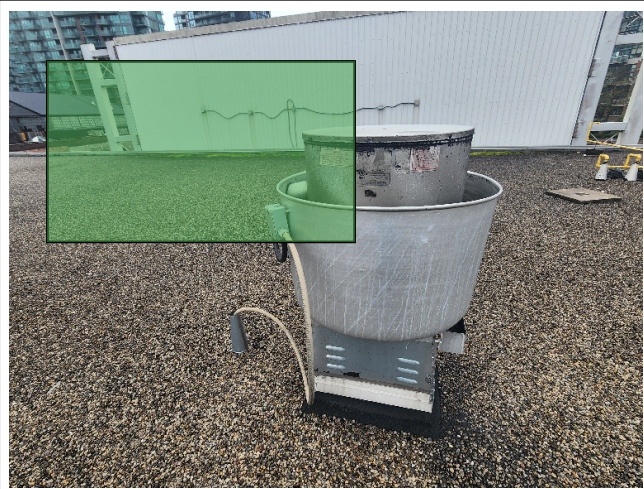
⑤ Description:

Open roof cone needing to be sealed in order to keep it watertight.

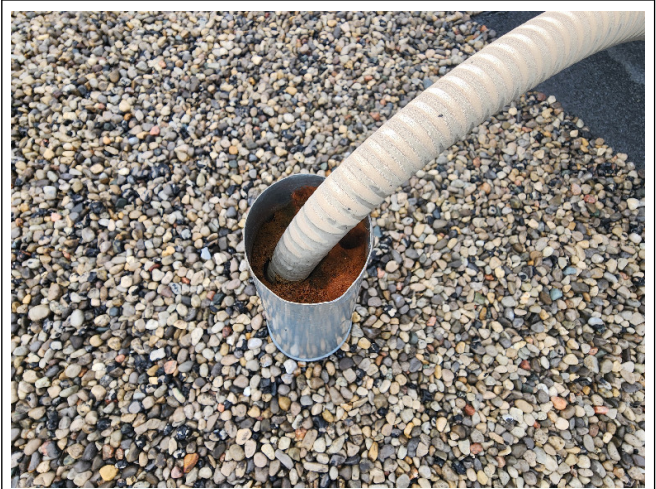
⑥ Description:

A close-up of the open roof cone for the electrical conduit.

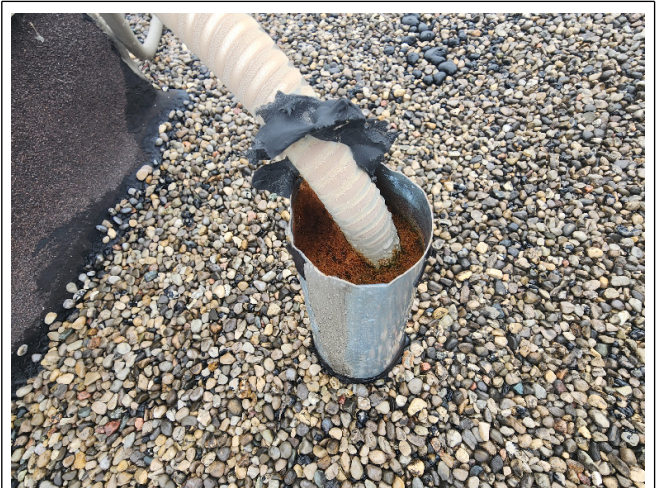
⑧ Description:

A close-up of the open roof cone, showing the exposed sprayfoam insulation.

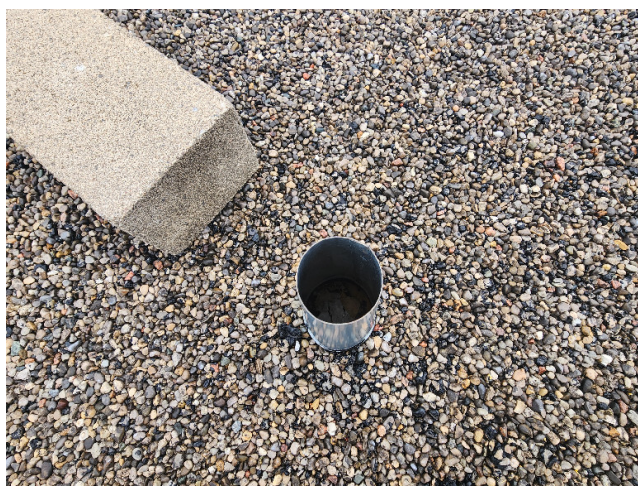
**9** Description:  
Open roof cone will need to be covered to prevent water and debris to enter.

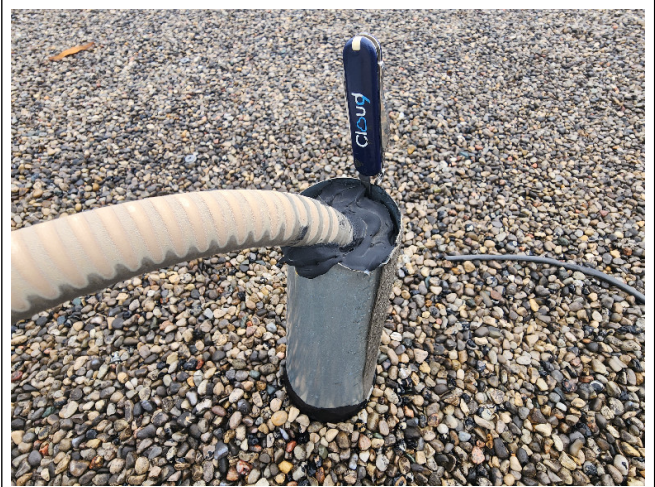
**10** Description:  
Opening in the sealant of the cone.

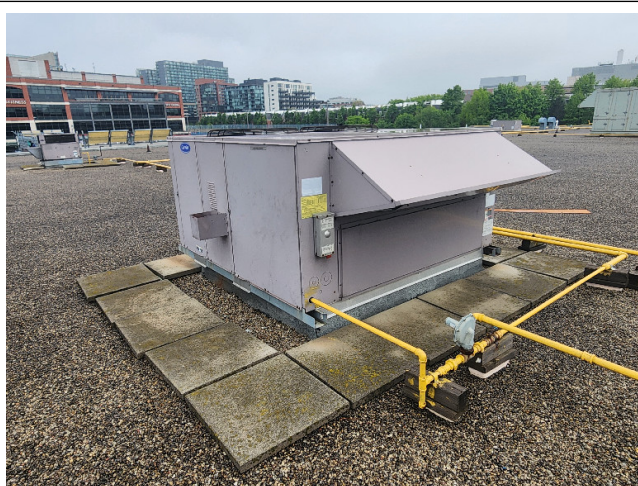
**11** Description:  
Typical HVAC unit on this roof level.

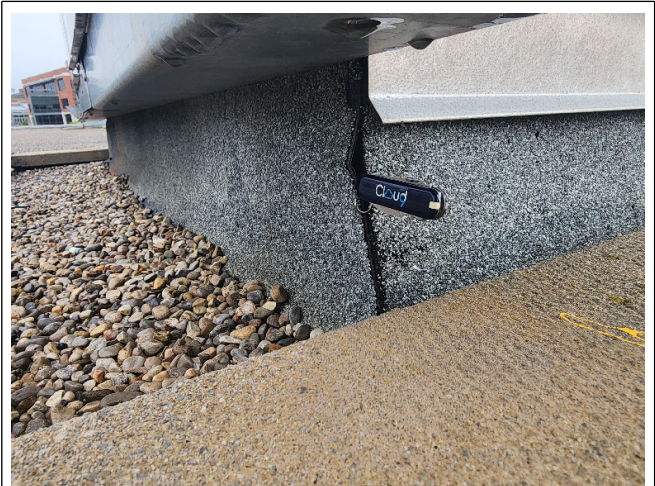
**12** Description:  
Opening in the flashing under the HVAC unit allowing for moisture infiltration.

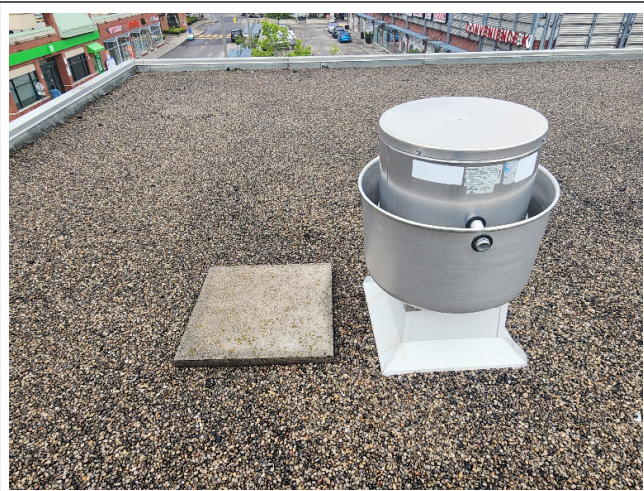
**13** Description:

Missing insulation under the concrete roof paver.

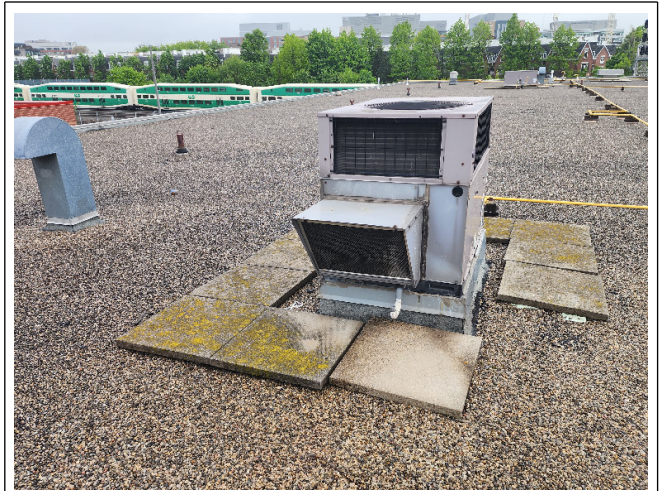
**14** Description:

More missing insulation cushions under the concrete pavers around the HVAC unit.

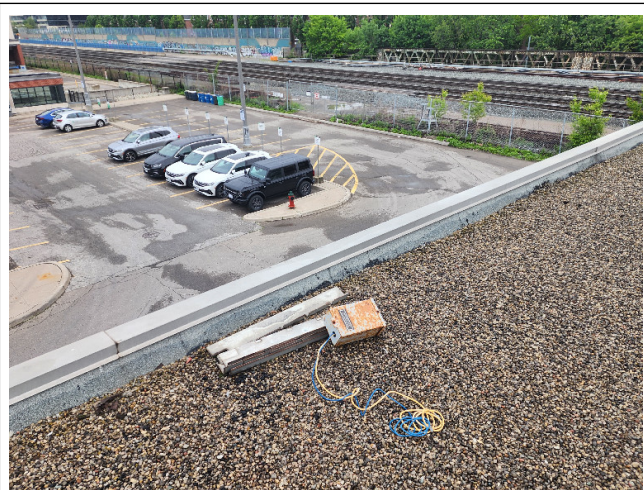
**15** Description:

Debris that should be removed from the roof before it blows over the parapet.

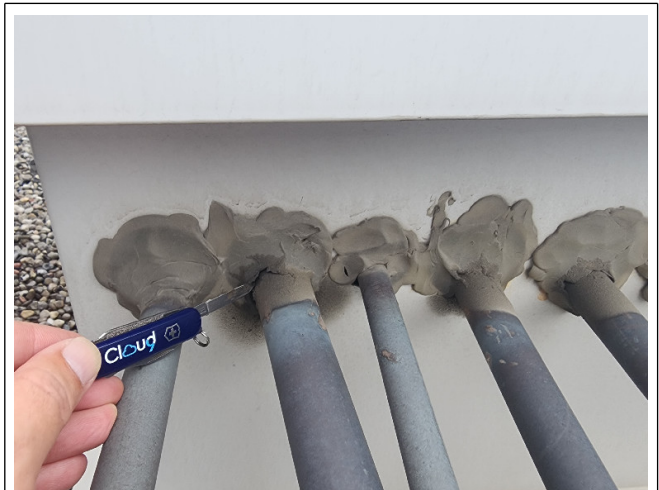
**16** Description:

Opening in the sealant on the dog house.

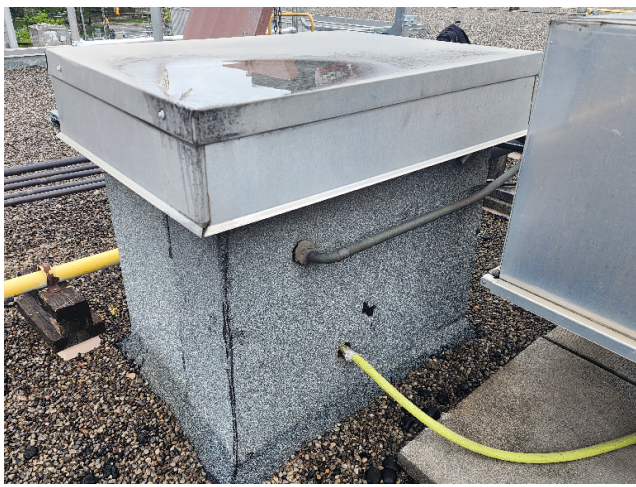
**17** Description:  
Opening on the doghouse.

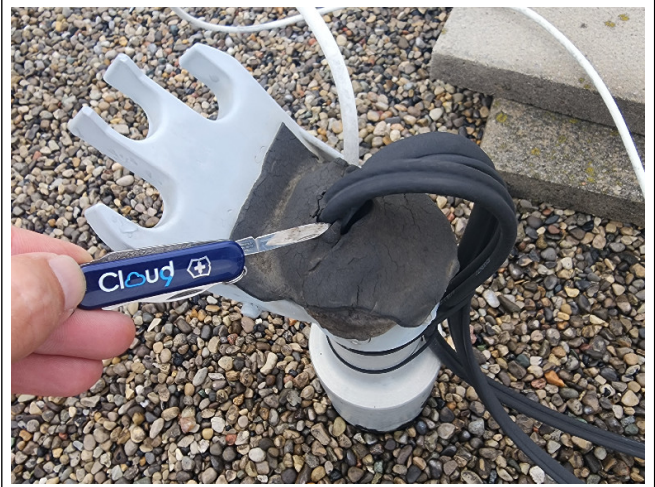
**18** Description:  
Open sealant at a roof cone.

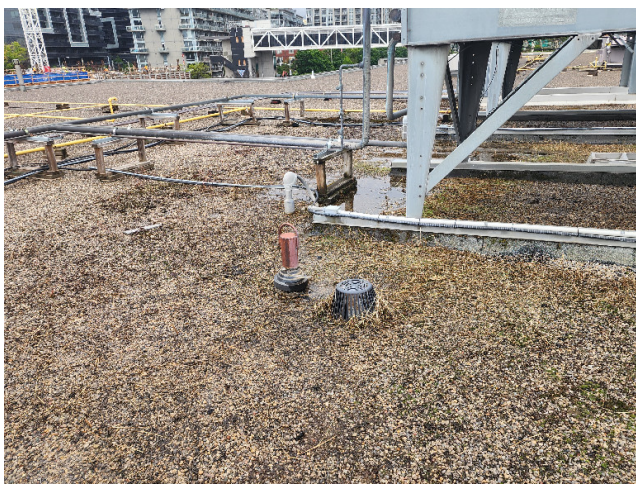
**19** Description:  
Overview of large amounts of organic debris around the roof drain.

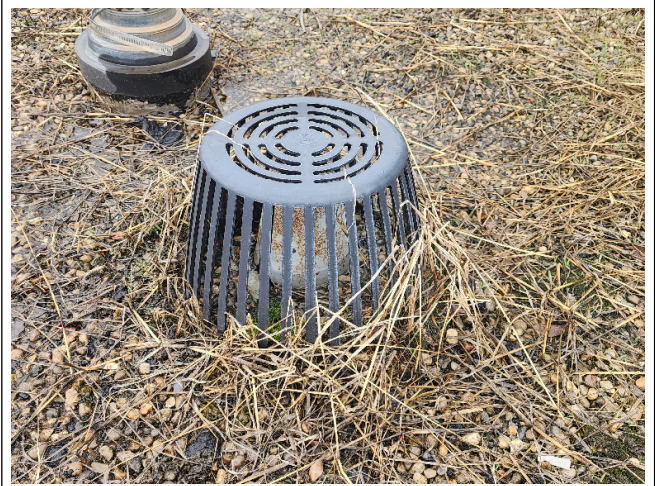
**20** Description:  
Organic debris built up around the roof drain not allowing for proper drainage.

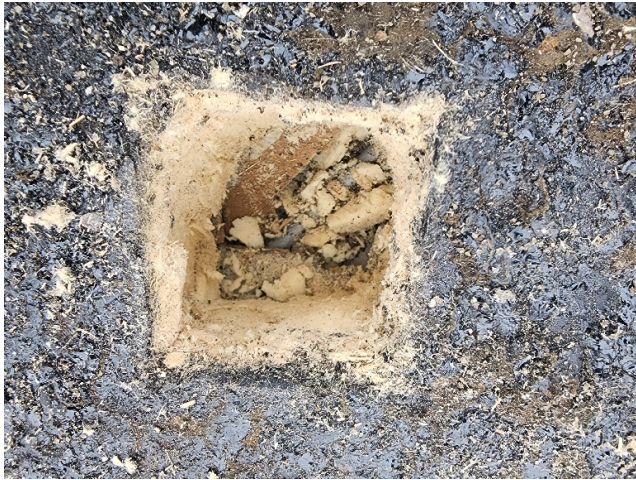
②1 Description:

A core cut showing the existing roofing assembly.

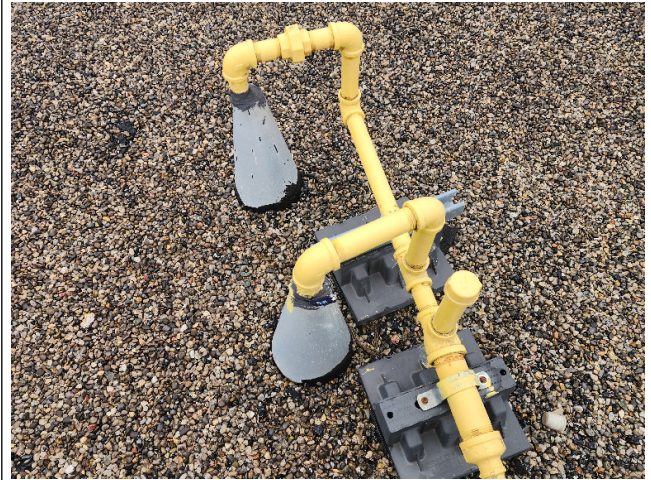
②2 Description:

Open sealant at the gas line penetration.

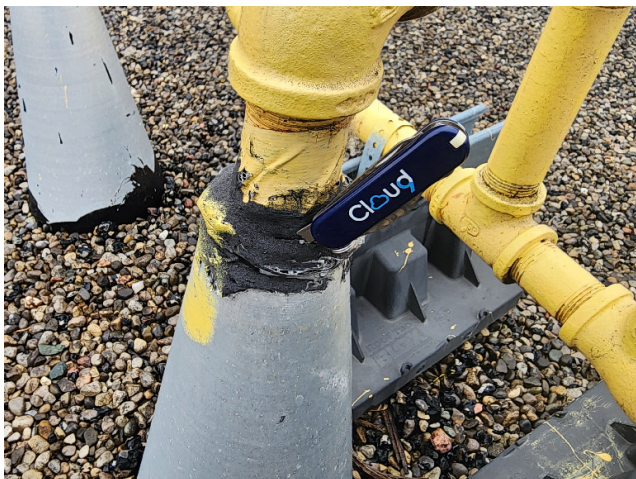
②3 Description:

A close-up of the open sealant.

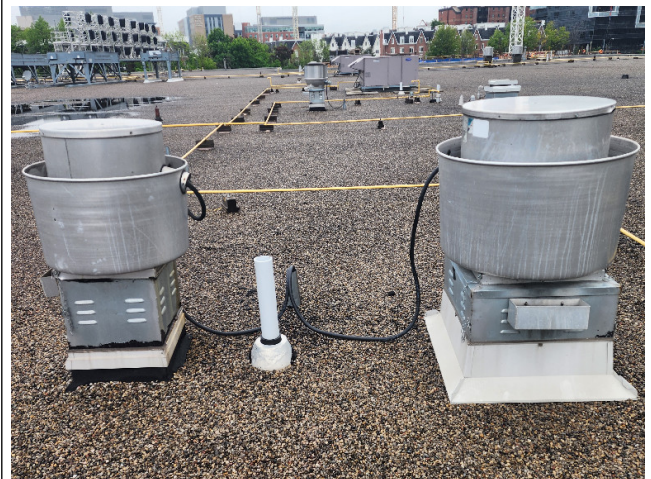
②4 Description:

Another open roof cone needing to be sealed.

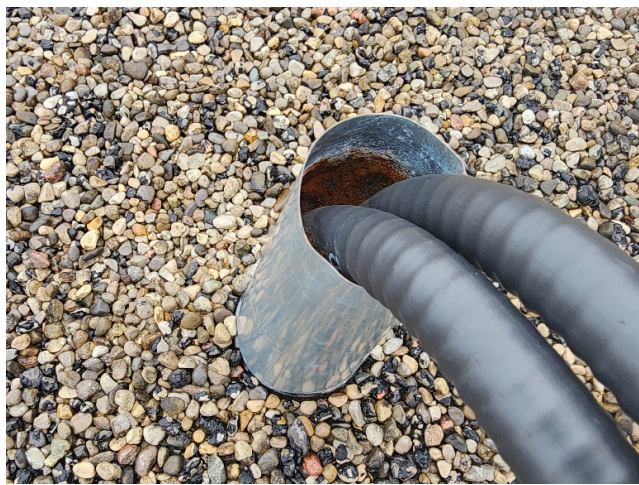
25 Description:

A close-up of the open cone.

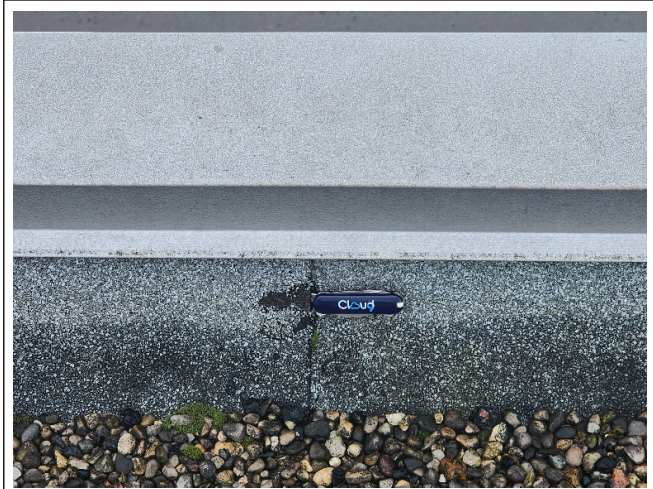
26 Description:

Open lap in the flashing membrane.
