EBS Innovations Inc.

Inspection Date: Nov 20, 2025	Inspector: Chuck Smith	Roof Area: Value Village
Client: Biddington Property Mgmt.	Weather: Clear	Temp: 4°C
Project Name: Downsview Plaza	Progress: 15%	Prov: ON M3K 1G6
Address: 1050 Wilson Avenue	City: Toronto	
Roofing Contractor: ABC Roofing	Foreman: Pedro	Crew Size: 10
Type of Roofing Project: Replacement		
Roof System: Conventional		
Surfacing: Pea Gravel		Attachment: Asphalt
Membrane Type: 4-Ply Hybrid BUR		Attachment: Asphalt
Cover Board: Yes	Type: DensDeck	Thickness: 0.50"
Insulation: Yes	Type: Polyiso	Thickness: 2.5"
Vapour Retarder: Yes	Type: Mod. Bit.	Attachment: Self-Adhesive
Deck Type: Metal

Site Plan with Progress Markups

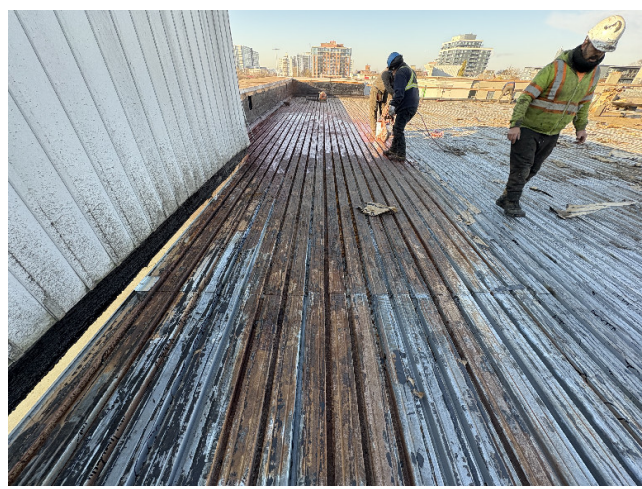
① Description:

Work area along the Southwest corner of the roof. Approximately 350 sq.ft. of rusted metal deck was found and painted with rust inhibiting paint.

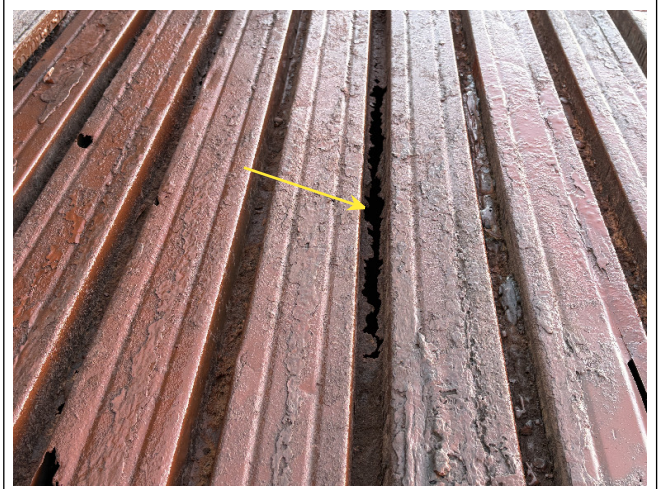
② Description:

Close-up photo of the rusted metal deck. The deck was rusted right through in certain areas, which were covered with a metal plate, where required.

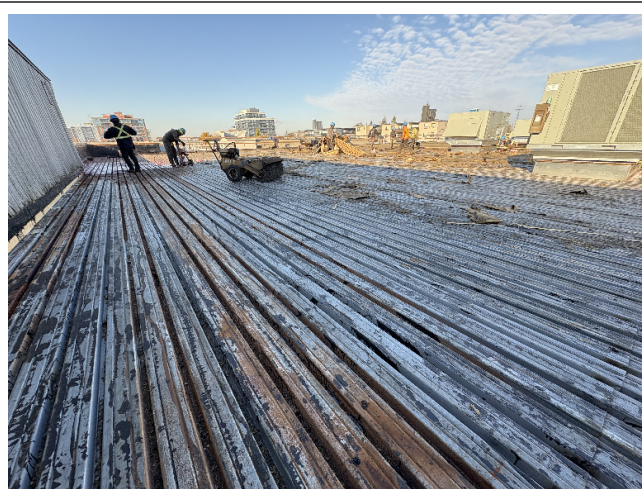
③ Description:

Another area along the South perimeter of the roof where the metal roof deck was found to be in good condition.

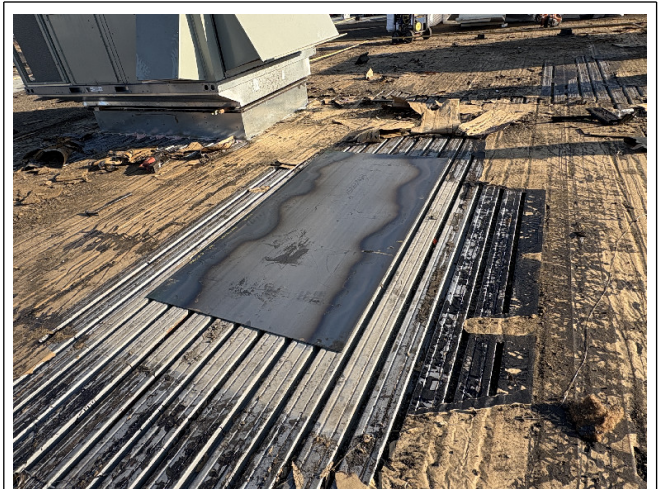
④ Description:

Overview of the steel plate that was mechanically fastened through the deck to help reinforce an area where a redundant roof curb was removed.

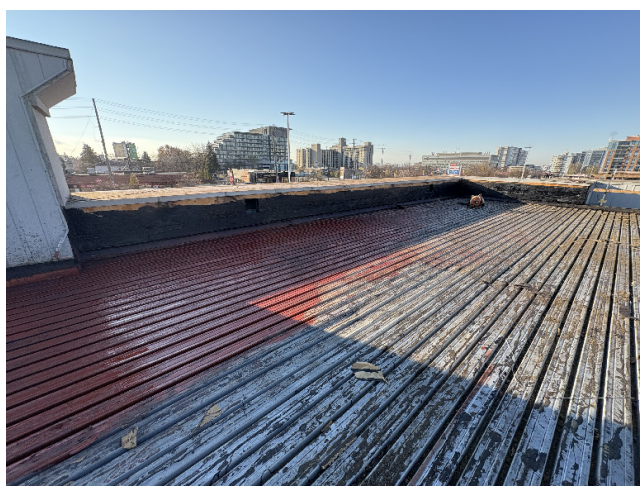
⑤ Description:
Overview of the area where rust-inhibiting paint was applied to the metal deck in today's work area.

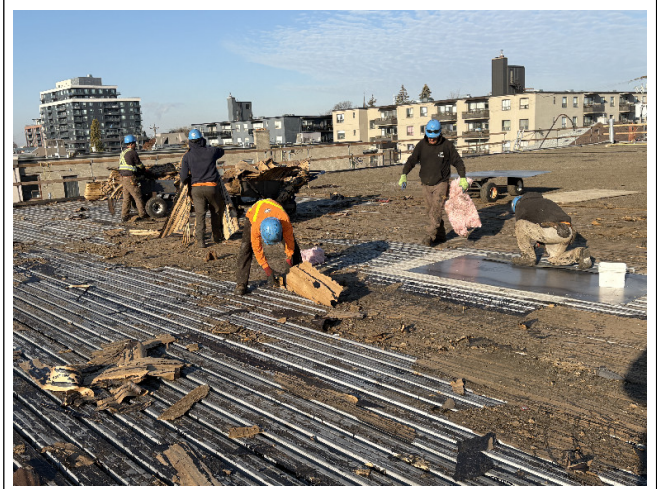
⑥ Description:
The roofing crew removing the existing vapour retarder from the metal deck before starting the new roof build-up installation.

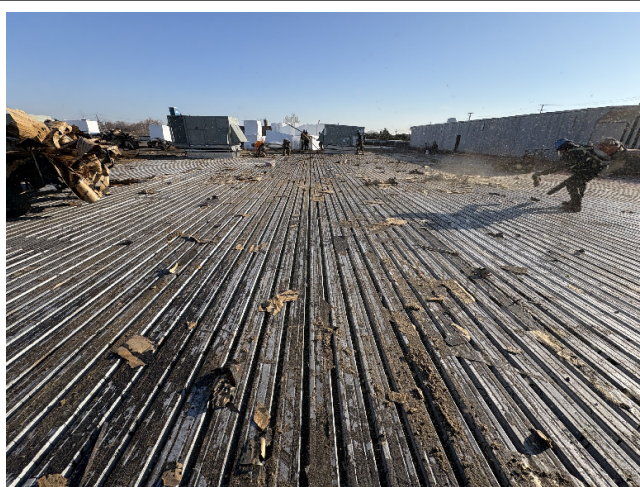
⑦ Description:
The roofing crew was using a blower to remove any remaining debris from the flutes of the metal deck, before beginning to install the new roofing assembly.

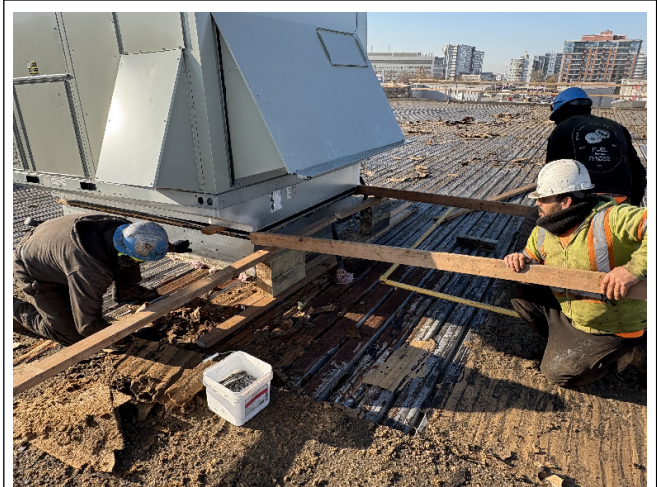
⑧ Description:
The roofer was using lumber to temporarily lift the HVAC units to install the new flashing membranes up and over the roof curbs.

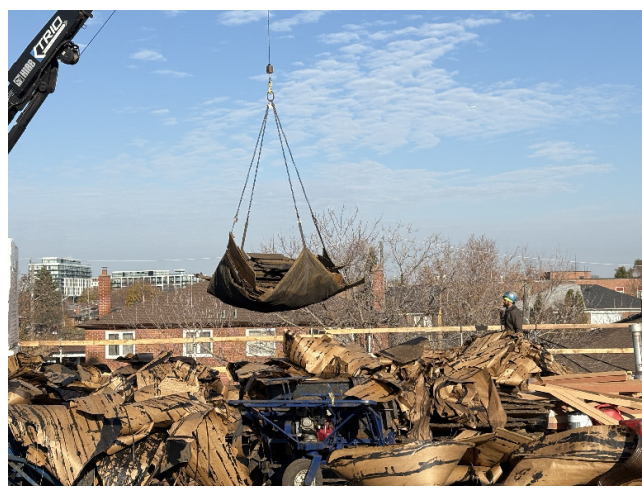
⑨ Description:

The roofer was using a mobile crane to dispose of the old roofing system into the garbage bins at ground level.

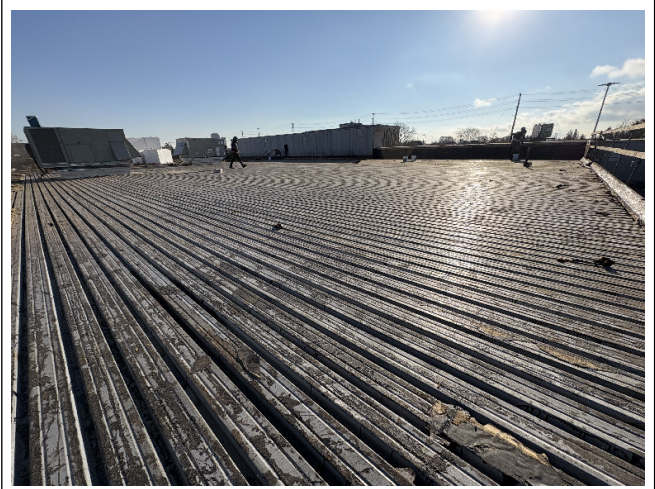
⑩ Description:

Overview of the clean roof deck, ready for the new roofing assembly.

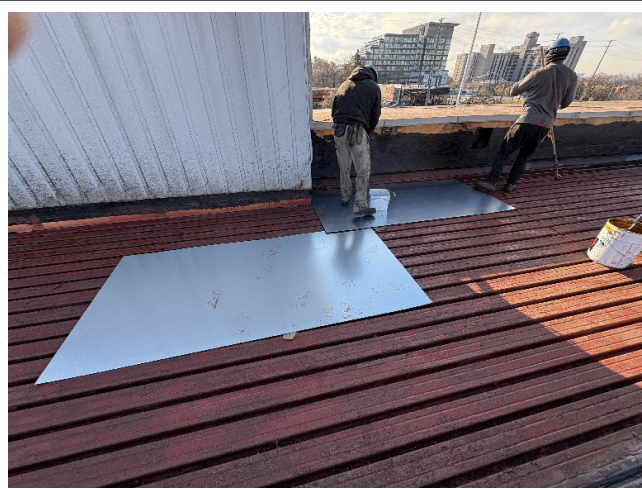
⑪ Description:

An area along the South perimeter of the roof, where the roof deck was painted with rust-inhibiting paint, and a few steel plates were required over the roof deck.

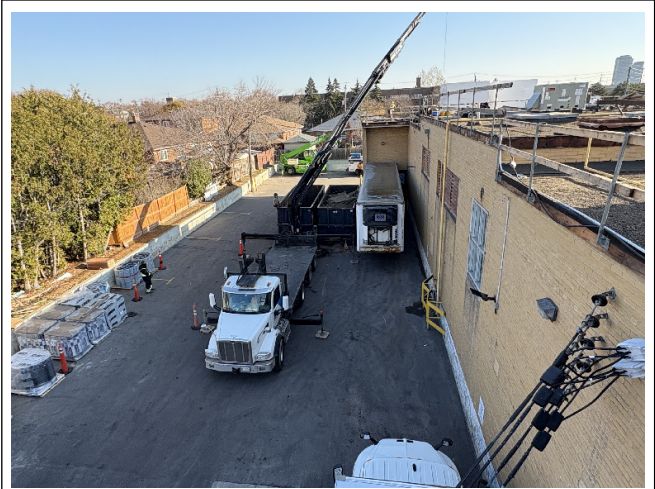
⑫ Description:

Overview of the setup area along the back of the building.
